Intel® Celeron® Processor in the 478-Pin Package

Specification Update

Document Number: 290749

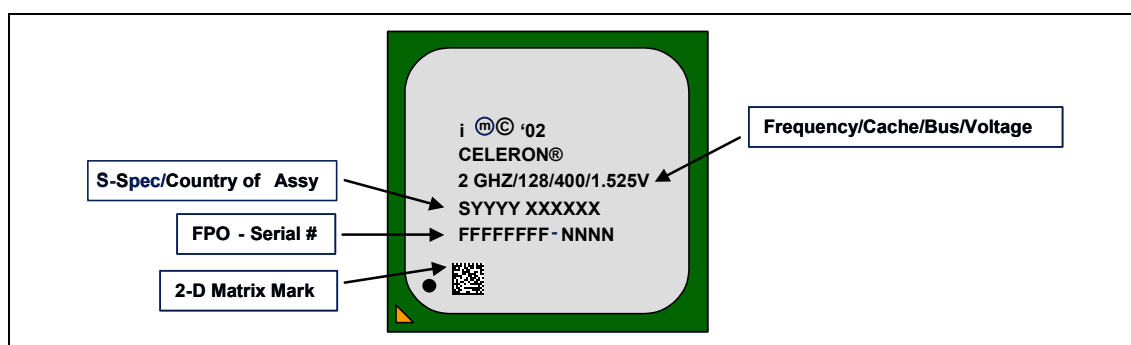
Figure 1. Example Markings for the Intel® Celeron® Processor on 0.13 Micron Process and/or in the 478-Pin Package

The Celeron processor in the 478-pin package may be identified by the following component markings:
